NASA
**RL10 IGNITION LIMITS TEST
FOR SHUTTLE CENTAUR**

FINAL REPORT

CONTRACT NAS3-22902

**Prepared by
United Technologies Corporation
Pratt & Whitney
Government Products Division
P.O. Box 109600, West Palm Beach, Florida 33410-9600**

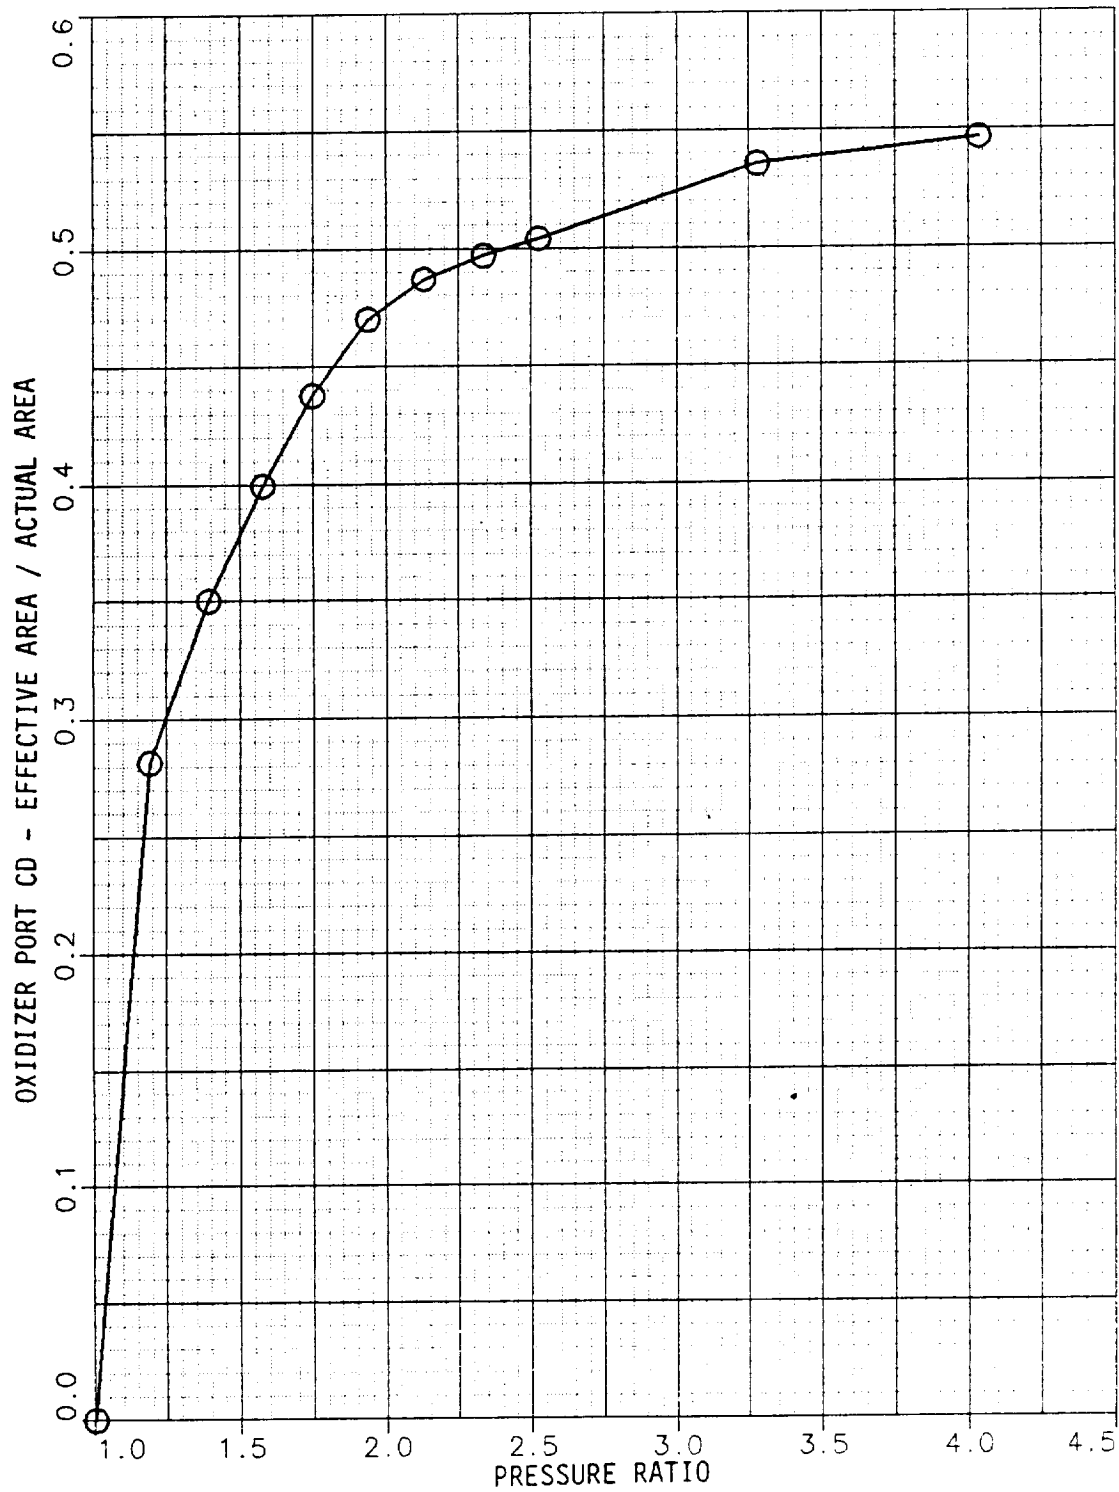
Figure B-1. Igniter CD — Oxidizer Holes

The igniter oxidizer holes were flow tested with nitrogen over a range of pressure ratios. Cd was back-calculated from the flow data and found to be a function of pressure ratio. A curve of Cd vs pressure ratio was generated (Figure B-1) and used to calculate flow for the test data. The calculation procedure used was:

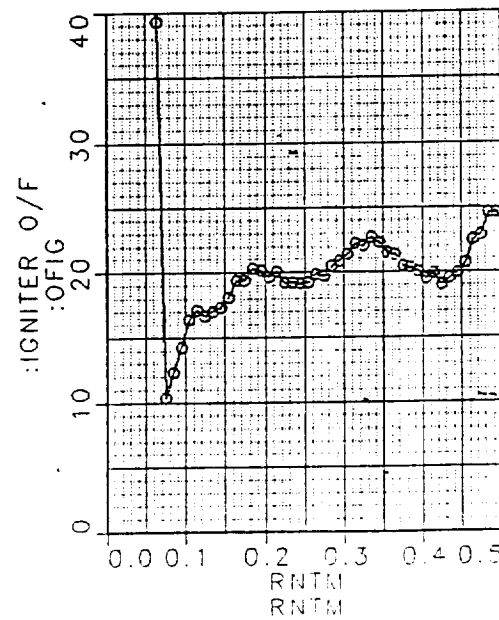
Figure-2 presents a typical run with evacuated fuel cooldown valves. Chamber mixture ratio is shown to be well positioned, but chamber pressure is below the predicted ignition range. Igniter conditions are shown to be near the oxidizer lean side of the ignition range. A calculated chamber pressure is used because of the slow response of the measured chamber pressure.

PRATT & WHITNEY, ROCKET PERFORMANCE
 FIRST BURN, VOLTAGE TO IGNITER AT 0.2 SEC
 EVACUATED FUEL COOLDOWN VALVES
 XR105, BUILD 3, RUN 40.01

RESULTS --- ON LIGHT
